U.S. ENVIRONMENTAL PROTECTION AGENCY POLLUTION/SITUATION REPORT 2015 Gold King Mine Release SITREP

Subject: SITREP #4

Gold King Mine Release

San Juan County, Colorado

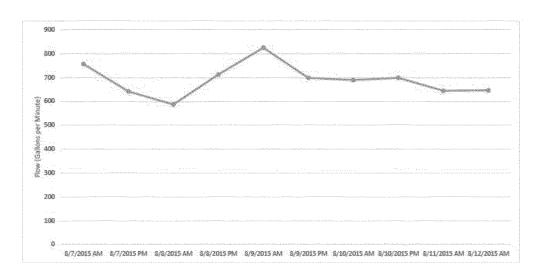
The EPA continues to operate four treatment and sedimentation ponds at the mine site which are treating water by lowering acidity levels and removing dissolved metals. Flow from the mine through the morning of 8/12/2015 is shown in the following chart.

Treated water from the last treatment pond is discharging into Cement Creek at levels cleaner (higher pH and lower levels of metals) than pre-event, background conditions in the creek. Over the next several days, the EPA will make upgrades to the system to ensure its continued operation. Flow data out of the mine is being collected manually two times per day. Water quality data is being collected at the influent and effluent of the treatment
